# Cadmium Alternatives: Zinc-Nickel Electroplating & Repair of Aluminum Coatings

Presented at: SERDP/ESTCP Workshop February 27, 2008

Presented By:
Stephen Gaydos
Technical Fellow – M&P
Boeing – St. Louis
Environmental Assurance

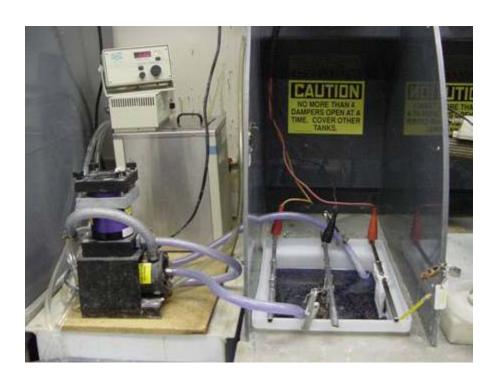
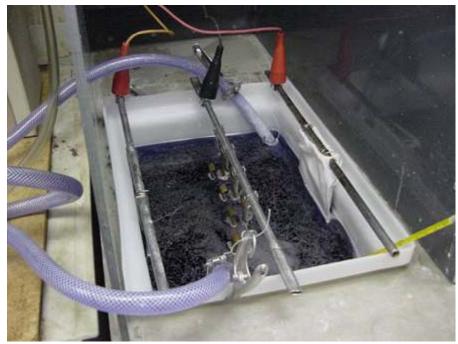
## IZ-C17 Zn-Ni Plating Tank

• 60 L Plating Tank Installed in Laboratory

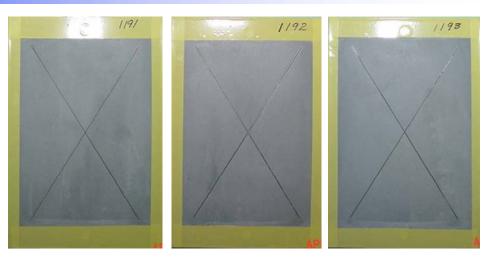
- LHE Cadmium Plating (Top) and IZ-C17 Zinc-Nickel Plating (Bottom)
  - Scribed ASTM B 117 Salt
     Spray Test after 1000 Hours
     Exposure
    - No Red Rust in Scribed Areas

LHE Cadmium Plating – 1000 Hrs. ASTM B 117 Salt Spray Exposure

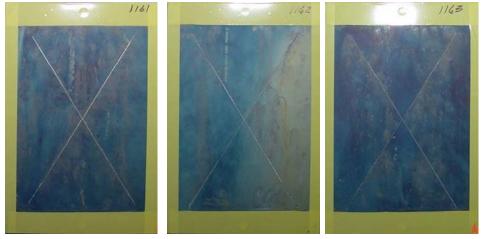
LHE Zinc-Nickel Plating – 1000 Hrs. ASTM B 117 Salt Spray Exposure

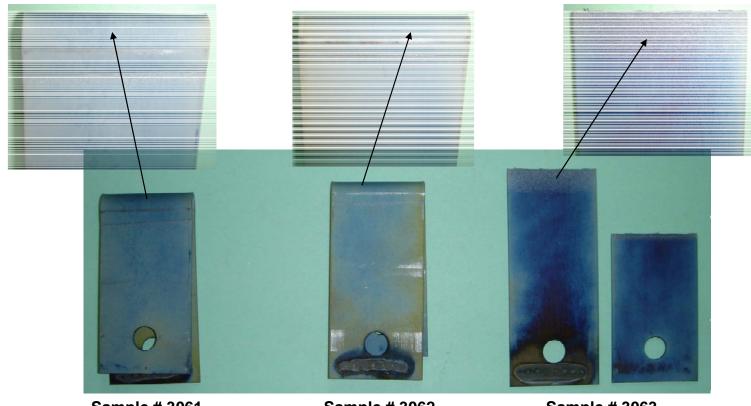
LHE IZ-C17 Zinc-Nickel on Steel

• IZ-C17 Has Good Adhesion and Uniform Thickness

**Sample # 3061**

Thickness = 0.45 + - 0.02

**DAC Adhesion = Pass**

**Sample # 3062**

Thickness = 0.47 + /- 0.02

Sample # 3063

Thickness = 0.44 + /- 0.04

Mil Spec Adhesion = **Pass**

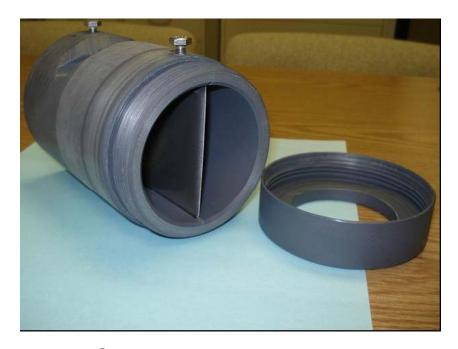
Hull Cell Test Panel Inserted In Plastic Tube

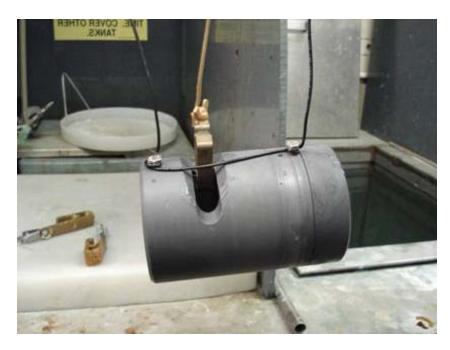
Tube with Hull Cell Test Panel Placed in Zn-Ni Plating Bath

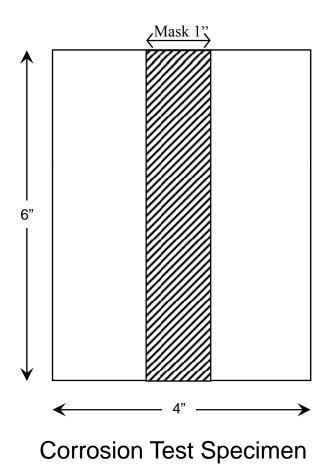
# Repair Test Specimens

Adhesion Test Specimen

4130 Steel with IVD Aluminum Applied

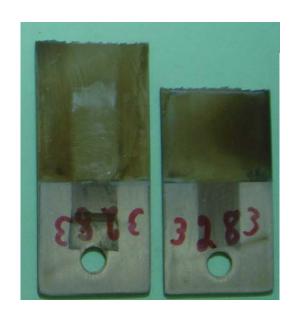
- Adhesion of LDC 5030 Brush Sn-Zn on IVD Aluminum is Good with the Nickel Strike
- Fatigue Test Results for Brush Sn-Zn are Similar to Brush Cd Plate

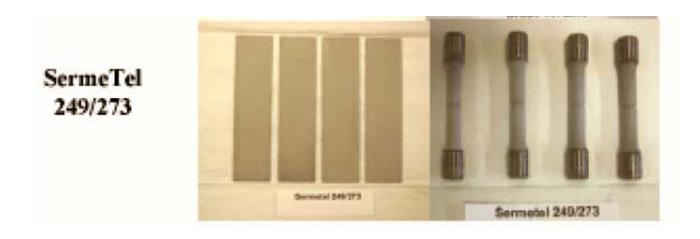
#### **SermeTel 249/273**

- Repair Specimens Prepared for JG-PP JTP Phase I
  - SermeTel 249/273 Applied to Bare Steel for Hydrogen Embrittlement and Adhesion Testing in Phase I
    - Failed Adhesion but Passed HE Tests
- Additional Type 1a.1, 1x4 and 4x6 Samples Prepared and Shipped to CTC for Phase II Testing
  - No Results to Report

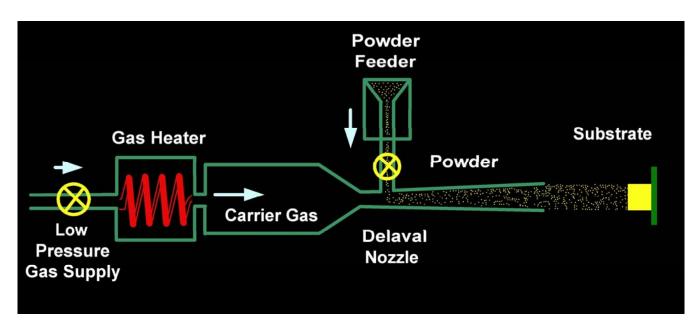
# **Cold Spray Aluminum**

- Cold Spray Particles Impacting on Substrate Do Not Melt
- Process Adaptable to Wide Variety of Operating Conditions (Supply Gases, Gas Temperature, Powders, Feeder Designs, Nozzle Designs, Manual or Robotic Application)

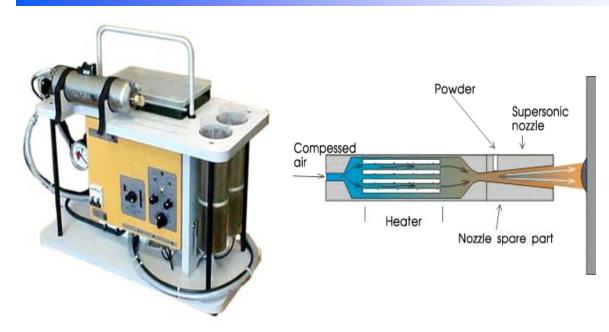
# **Dymet**

- Steel Test Samples Sent to Obinsk Center for Powder Spray (OCPS) for Application of Cold Spray Al with Dymet Equipment
- Coating Appearance was Acceptable But System Did Not Seem to be Operator Friendly

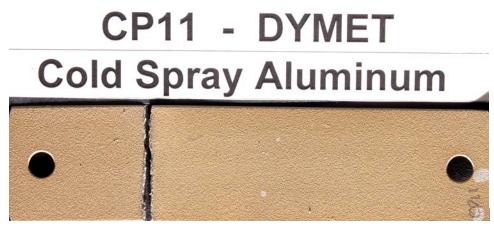
- Test Results for Steel Samples Received from OCPS with Dymet Cold Spray Al Coatings
  - Good Adhesion
  - Good Corrosion Performance (1000 Hr B 117 Scribed No Rust)
  - Process is Non-Embrittling to HS Steel
  - Thickness 1.5 to 2 mil

Passed Bend to Break Adhesion Tests

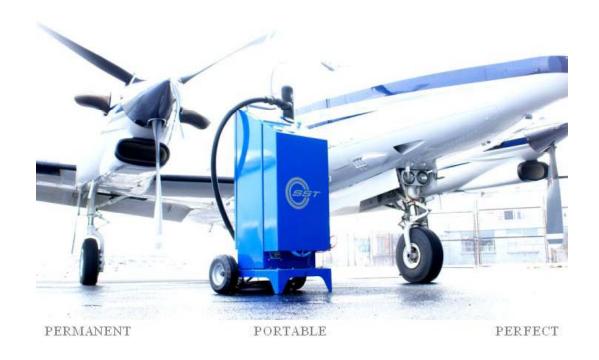
#### **Centerline SST**

Centerline SST Unit is Improved Version of Dymet Equipment

- Adhesion Testing Carried Out on Steel and IVD Aluminum
  - Passed Tape Adhesion Test
  - Passed Glass Bead Burnish Adhesion Test at 60 psig
    - This is the Adhesion Test Used for IVD Al
  - Some Flaking on Bend-to-Break Test
- Corrosion Test Results Carried Out on Damaged IVD Aluminum Steel Panels
  - Exceeded MIL-DTL-83488 Requirement
